Human–Wildlife Conflicts 2(2):206–211, Fall 2008

Evaluation of physical barriers to prevent prairie dog colony expansion

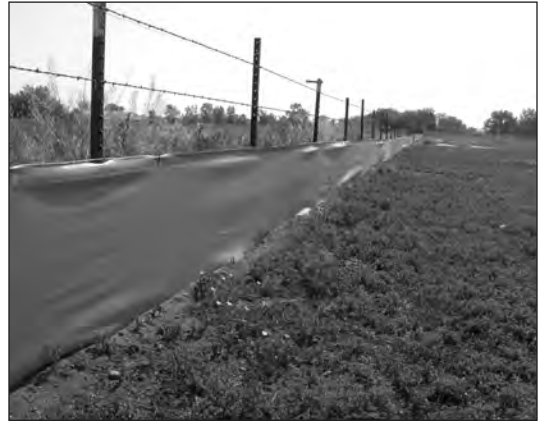
Figure 1. An intact vinyl barrier.
